Phase I Environmental Site Assessment

Stanley Assemblage
Perry, Houston County, Georgia

January 28, 2019

Prepared for:
City of Perry
EPA Cooperative Agreement: BF 00D71518-0

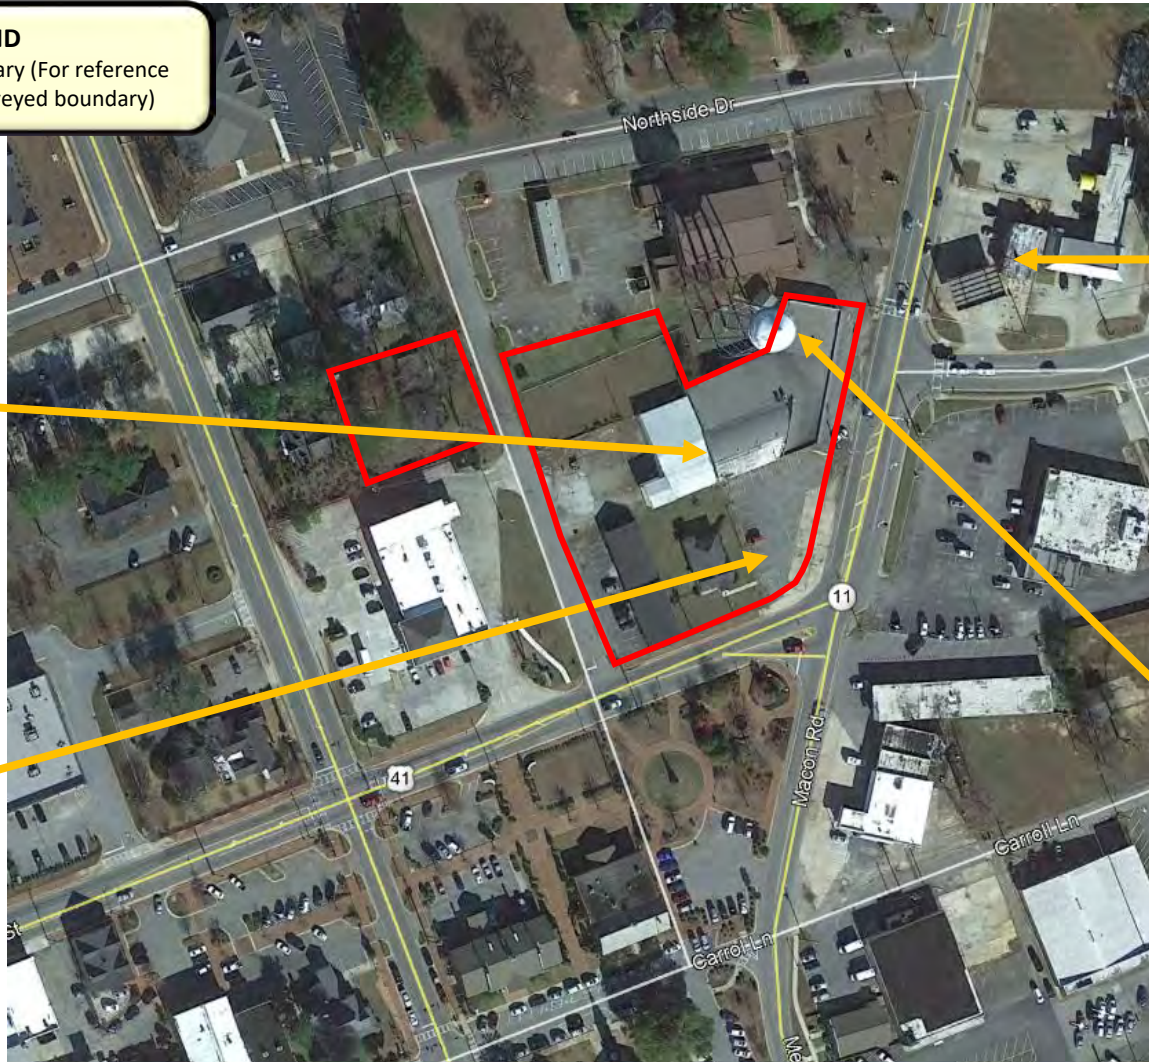
REC #3: Lack of groundwater sampling near the vicinity of the Star Cleaners and historic gasoline filling stations

REC #2: Inadequate sampling conducted in response to a historical gasoline servicing station located at 1101 Macon Street.

REC #4: Flash Foods #167 facility located at 1114 Macon Street is a gasoline filling station, adjacent the Subject Property

REC #1: identified PCE concentrations at the Star Cleaners Site located at 1109 Macon Street.

Protection Division (EPD) notification concentration (NC) beneath the facility flooring, as well as the adjacent driveway. Although multiple attempts to adequately sample and remove the contaminated soils have been conducted between 2014 and 2015 by representatives of Geotechnical & Environmental Consultants, Inc. (GEC), these attempts to horizontally delineate the extent of the contaminant plume and subsequent remedial efforts were unsuccessful. This contamination was reported to the Georgia EPD Hazardous Site Response Act (HSRA), and based on the elevated concentrations and lack of access limitations, the site was listed on the Georgia EPD Hazardous Site Inventory (HSI). The presence of PCE above its NC in soils within the boundaries of the Subject Site poses an environmental risk to the Subject Property and is considered a REC.

4. The Flash Foods #167 facility, located east of the Subject Property, across Macon Street at 1114 Macon Street is a gasoline filling station. This facility has been in operation since approximately 1989, with no reported hazardous spills. However, based on the length of operation, inferred upgradient position, and distance from the Subject Property, this facility is considered an off-site REC.

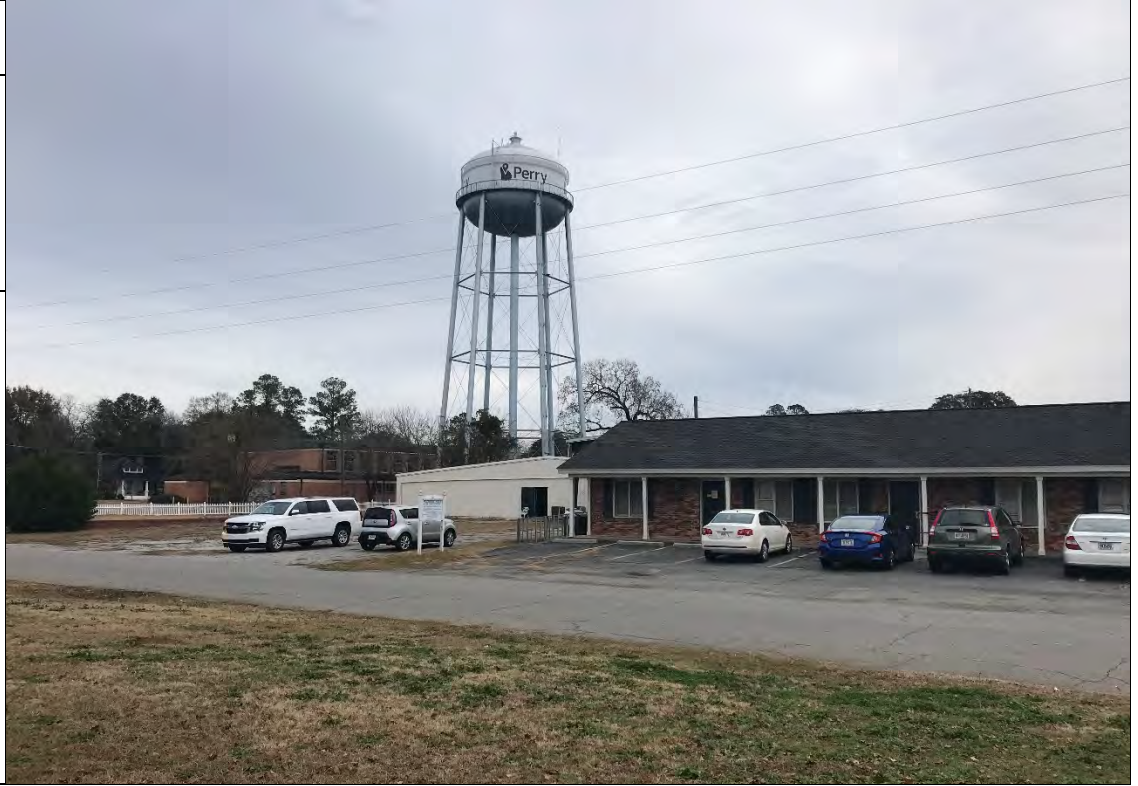
Photo No.
4

View of offices located at
1021 Commerce Street

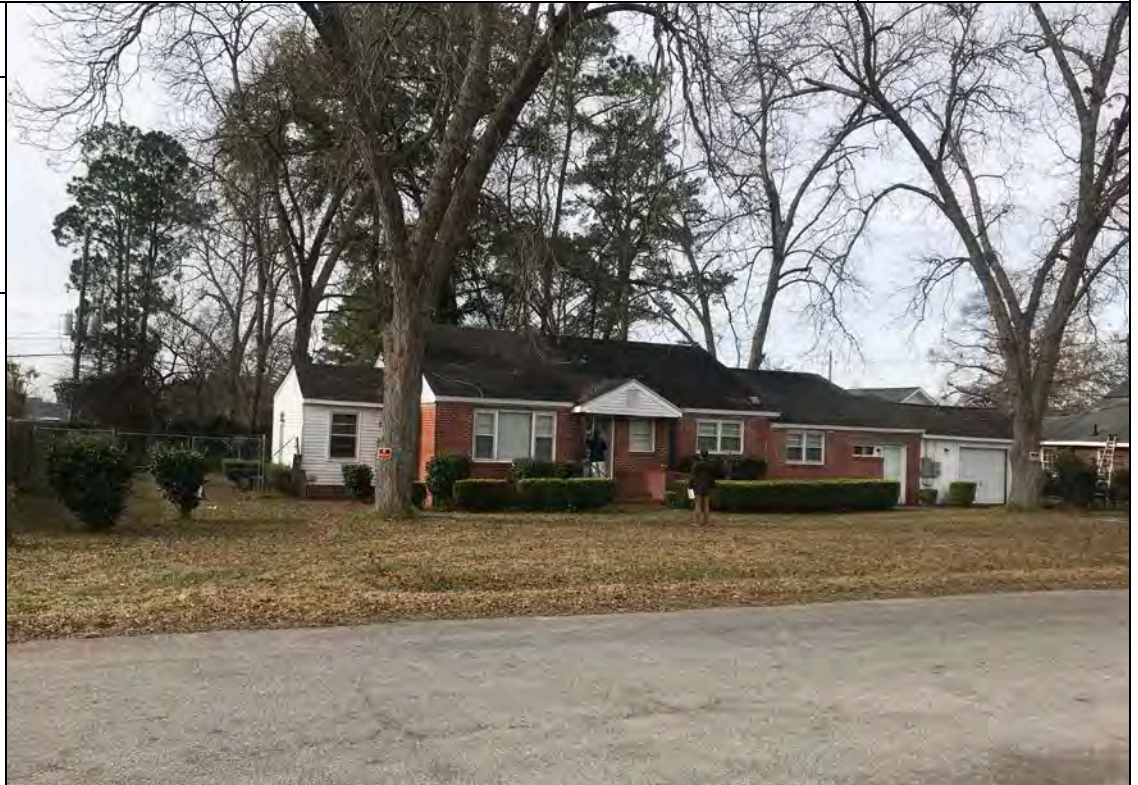
Photo No.

View of residential structure located at 1107 Meeting Street

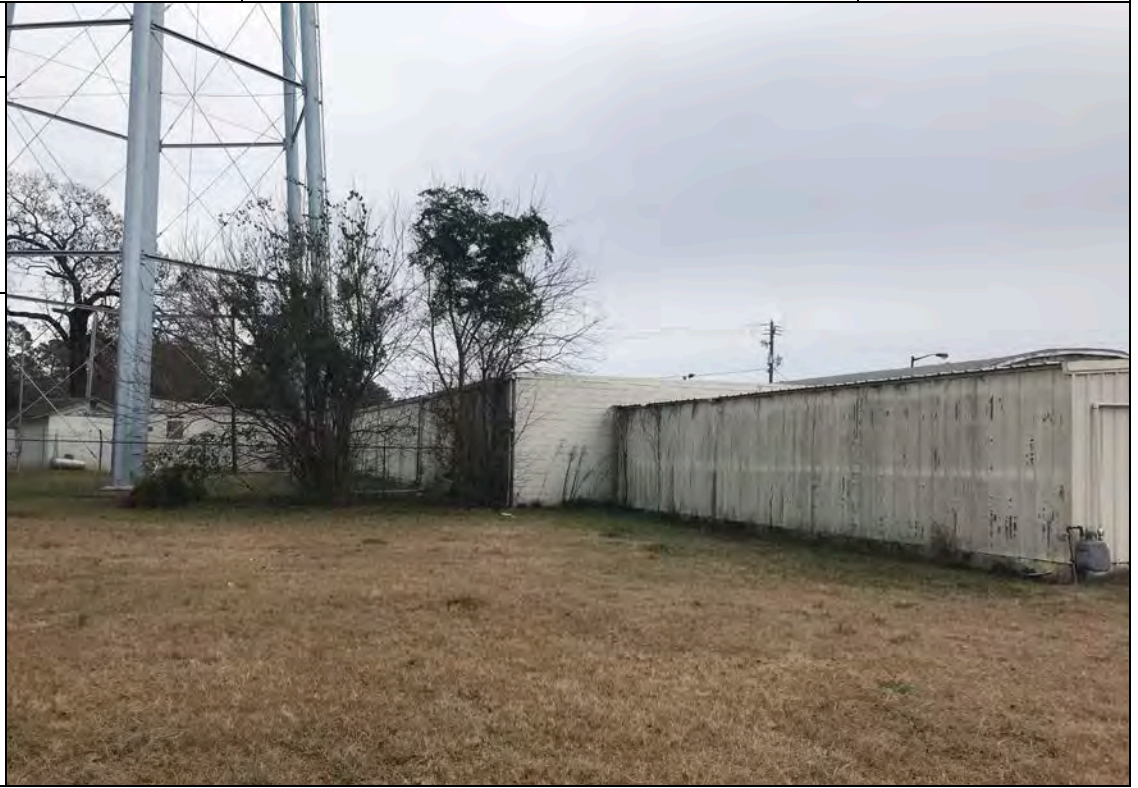
Photo No.
8

View of vacant land, near the center of the Subject Property, adjacent the Stanley Furniture building
